MX Parking Lot

Current Condition Review and Near-Term Repair Options

Visual review based on April 4, 2026 video clips and the [MX parking-lot webpage](#)

McKnight Crossings Church
2515 S McKnight Rd, St. Louis, MO 63124
April 4, 2026
video of asphalt parking lot

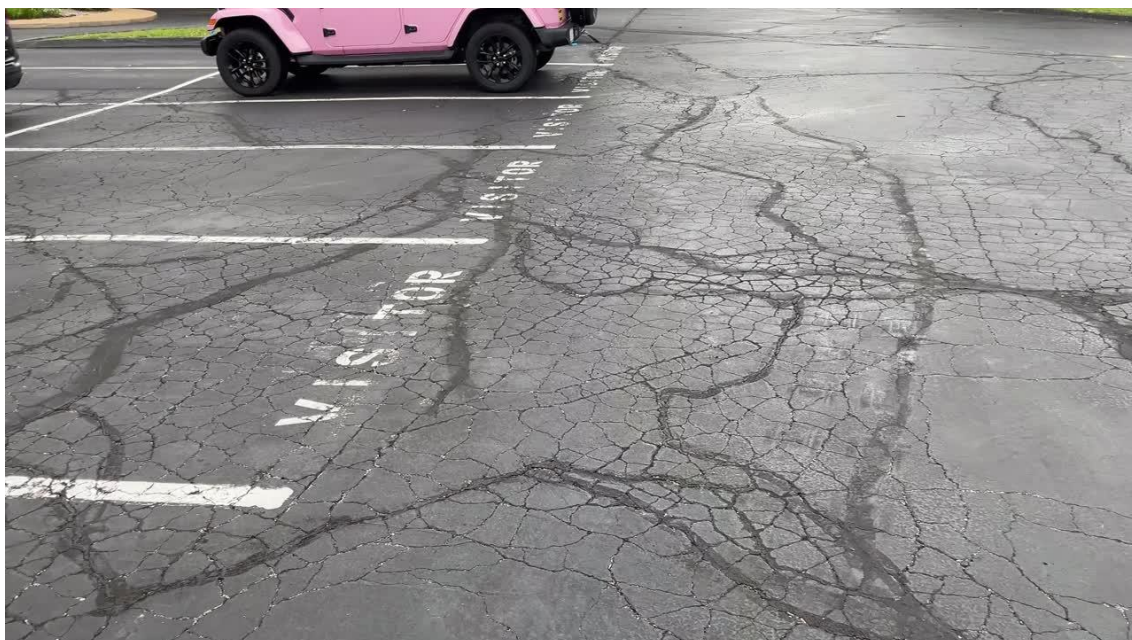
Dense alligator/fatigue cracking in a parking area. This is the type of distress least likely to be solved by crack seal alone.

- Yes, in the right places. It appears potentially useful for many of the long, open, linear cracks that are still reasonably intact at the edges and have not turned into full alligator failure.
- It appears less suitable as the main treatment for the heavily webbed or shattered sections. In those areas the problem looks deeper than a single crack line; sealing over the pattern may improve appearance briefly but usually does not stop continued breakup.
- If used, the best candidates would be cleaned, dry, clearly defined cracks where the surrounding asphalt is still holding together.

For this lot, the patch category should generally be used for localized failed spots and smaller broken sections. Broad alligator-cracked zones are more problematic. Those areas may accept temporary patching in the worst spots, but they are better understood as sections that are moving toward larger partial-depth repair, remove-and-replace work, or future resurfacing rather than simple cosmetic maintenance.

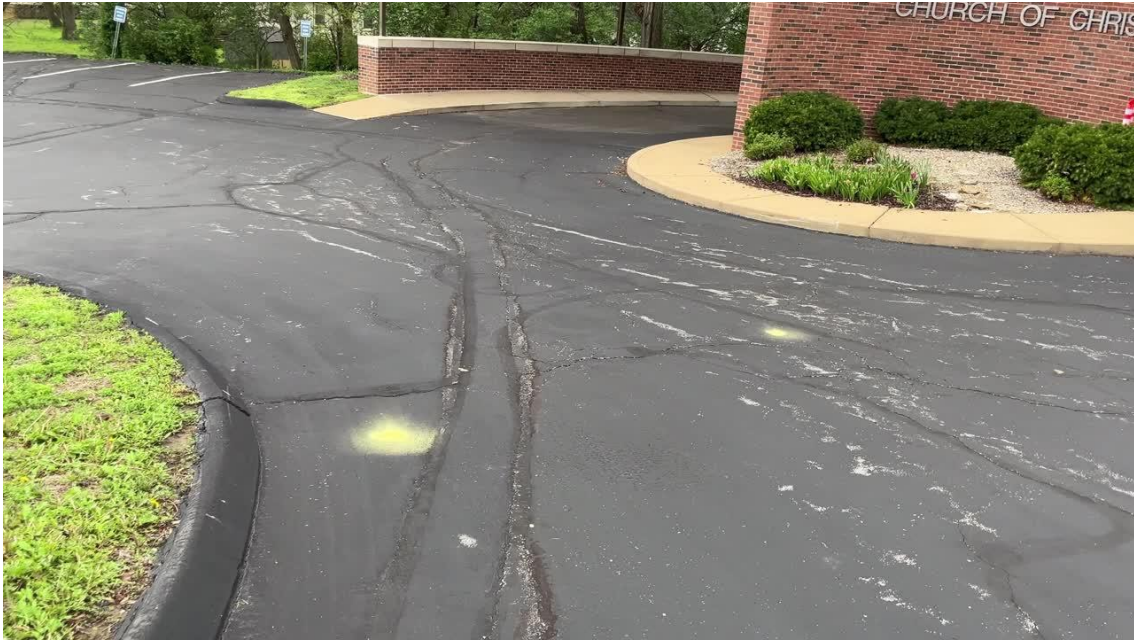
Drive lane / entrance areas	The drive-up areas near the building appear smoother overall but still show substantial long crack lines and movement.	These areas may benefit from crack sealing now, while watching closely for settlement or rutting.

Long working cracks and prior repair lines near the building drive lane.

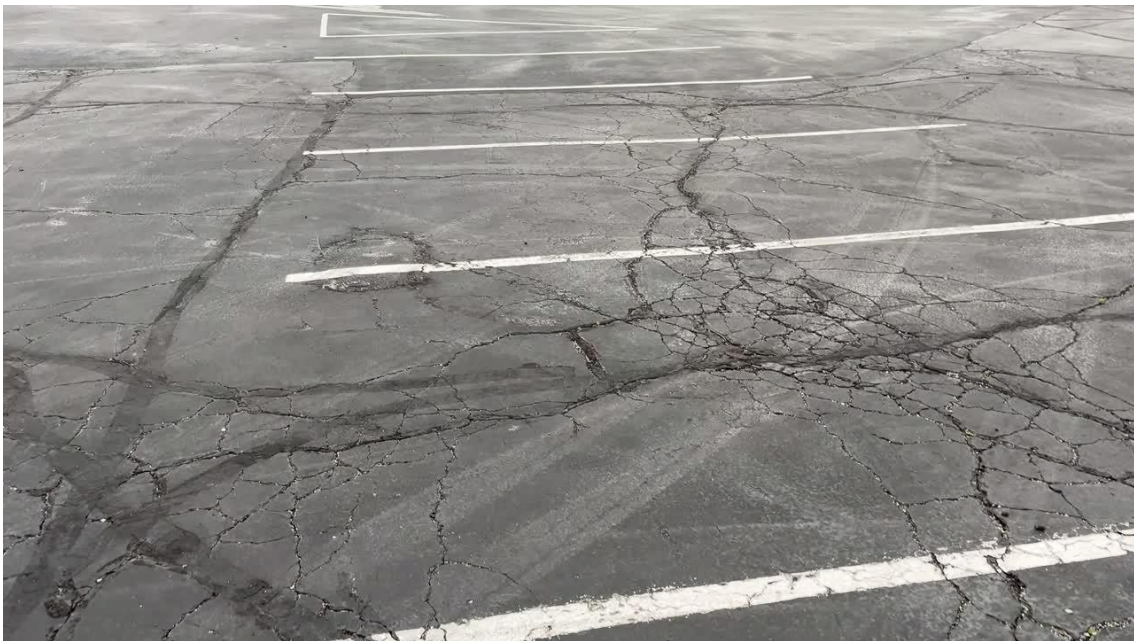
Interconnected cracking across a wider parking area, with both linear and fatigue-like distress visible.
